NATIONAL TRANSPORTATION SAFETY BOARD

RAILROAD ACCIDENT REPORT

HEAD-ON COLLISION BETWEEN
IOWA INTERSTATE RAILROAD EXTRA 470 WEST
AND EXTRA 406 EAST WITH RELEASE OF
HAZARDOUS MATERIALS
NEAR ALTOONA, IOWA
JULY 30, 1988

NTSB/RAR-89/04

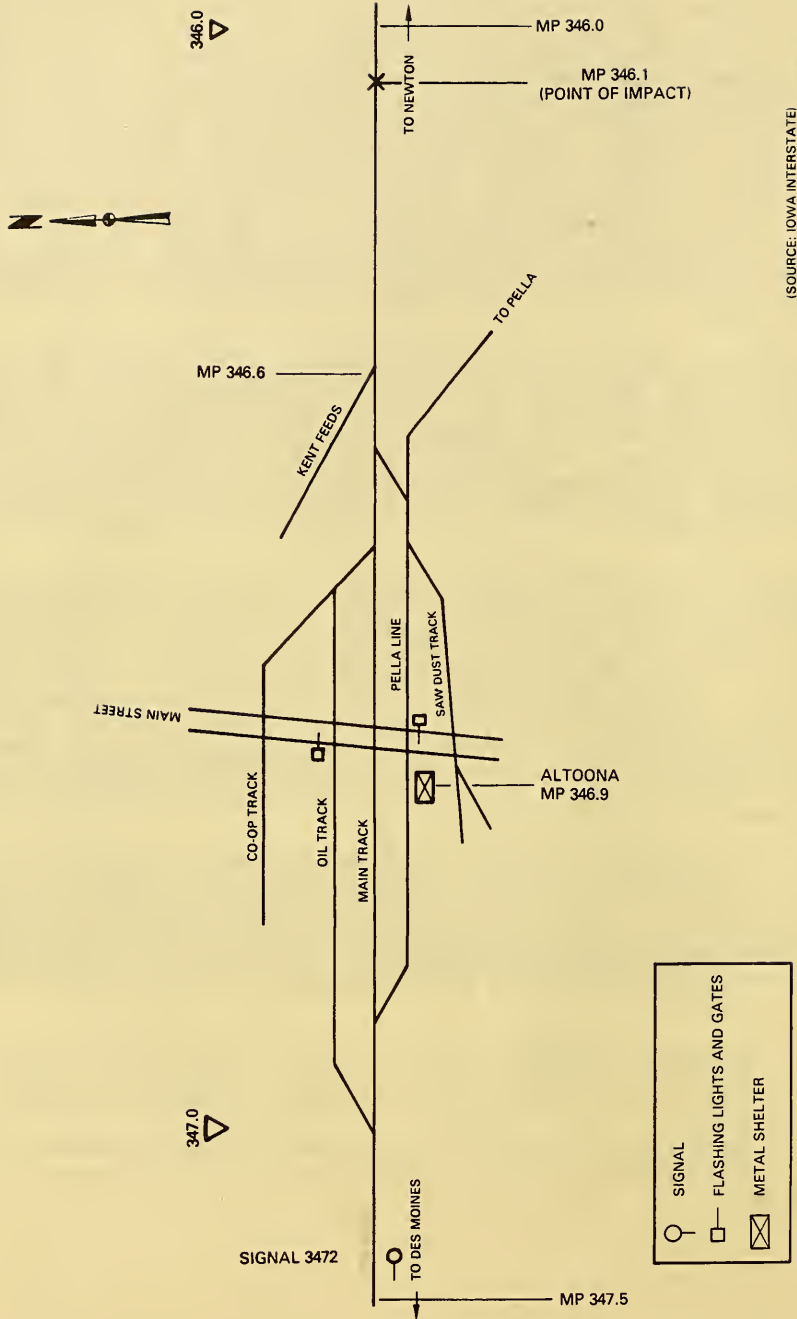
Figure 2.--Layout of Altoona Yard Track.

Safety Board investigators observed that signal No. 3472, located approximately 0.3 mile west of the Altoona station (see figure 2), had not been removed, covered, or turned away from the track.

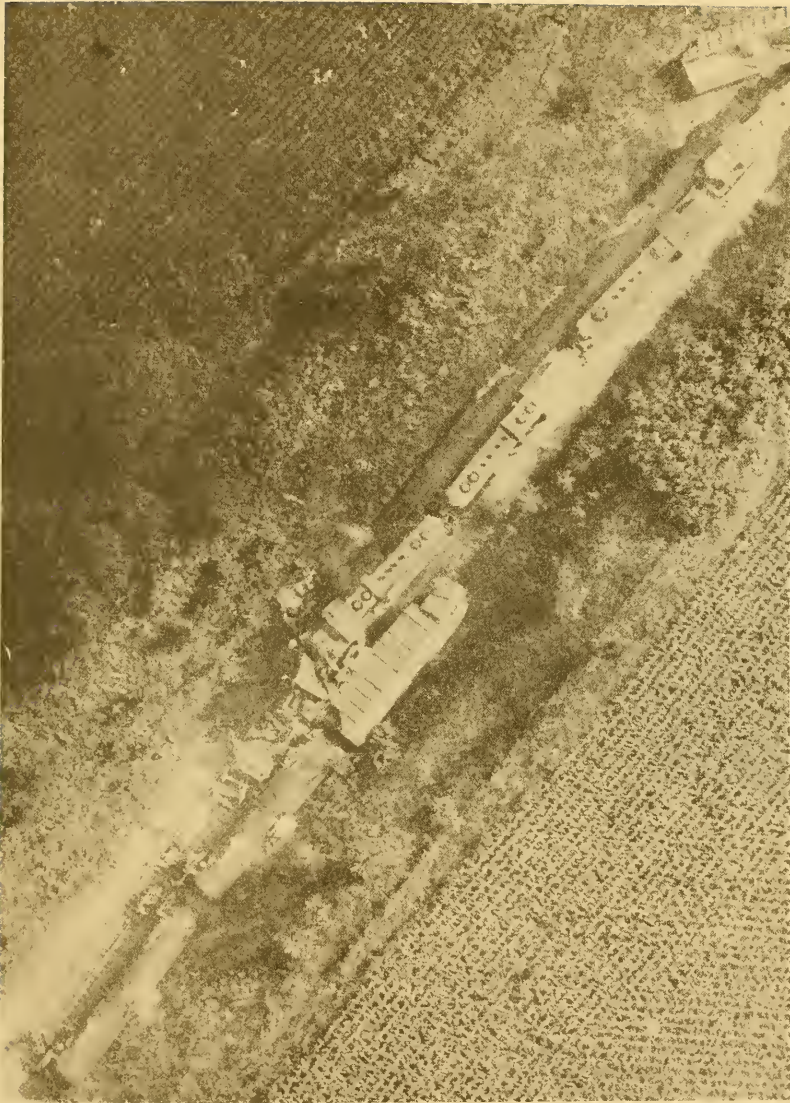
engineer observed Extra 470 West approaching. He estimated the two trains were about 300 feet apart and that his train was traveling between 15 and 20 mph at the time. He stated that "I thought I put the train in emergency. I shut the throttle down, put the train in emergency...." He stated that he left the engine through the cab door on the left (north) side of the cab of the engine, crossing over in front of the conductor who was sitting on that side of the cab doing paper work. He stated that as he was leaving the cab, he yelled at the conductor, "There's a train. Let's jump." The conductor stated that he did not hear the engineer say anything to him and that when he saw Extra 470 West coming around the curve, he positioned himself on the cab floor, braced his feet, and wrapped his arms around the control stand. A few seconds later, Extra 406 East and Extra 470 West collided head on within yard limit territory near MP 346.1. (See figure 3.)

Figure 3.--Extra 406 East (left) and Extra 470 West (right).

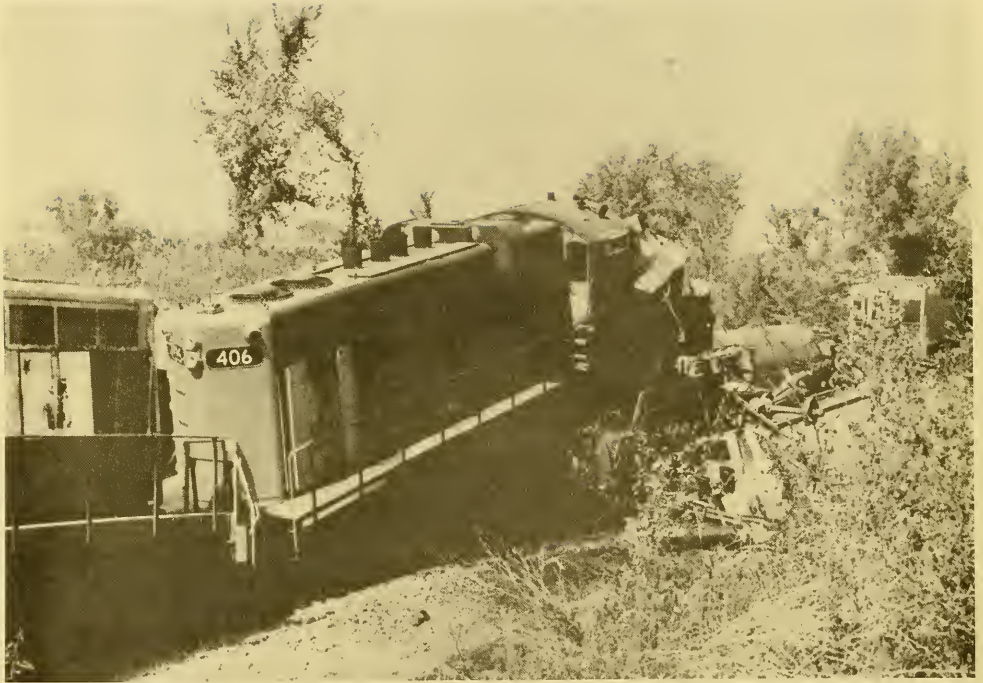
Figure 4.--Unit 406 Overriding Unit of 470 West.

was operating westbound with its long hood forward. As a result, the fuel tank on unit 406 was damaged. With the exception of slight deformation to the rear cab door, the cab compartment structure remained intact. The postcollision fire, however, destroyed the interior of the cab compartment.

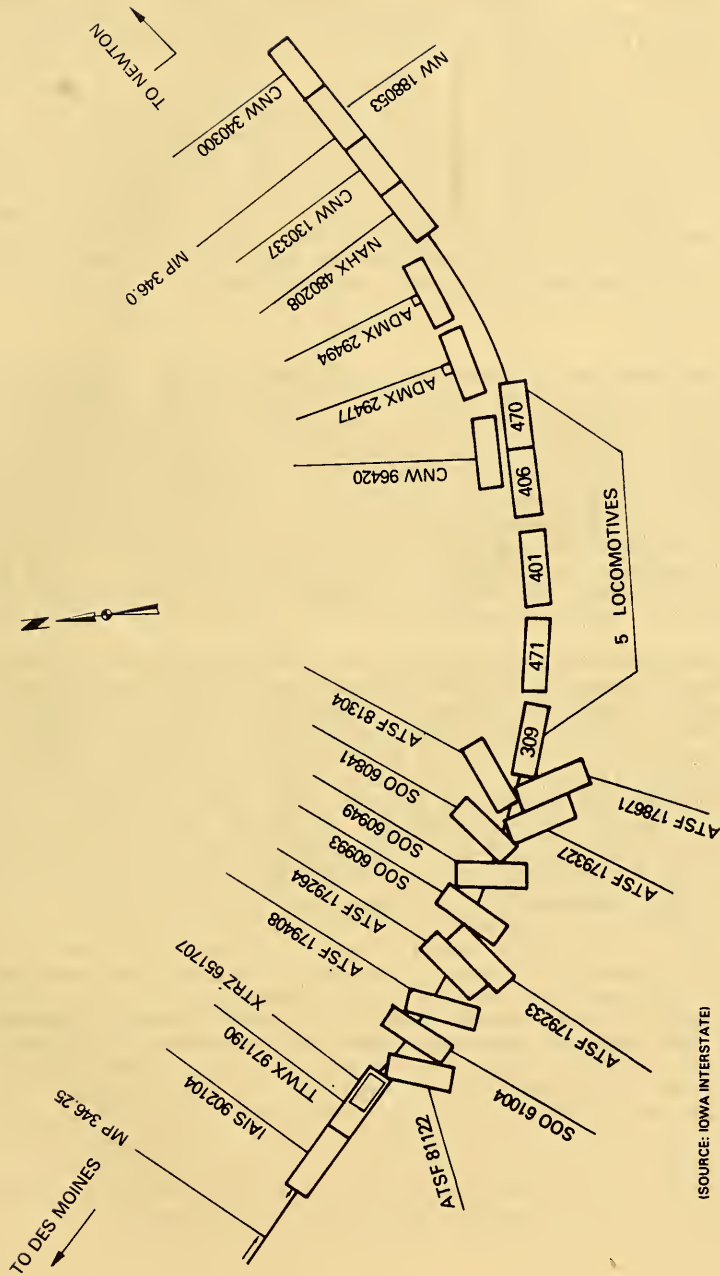
Figure 5.--Sketch of Derailment.

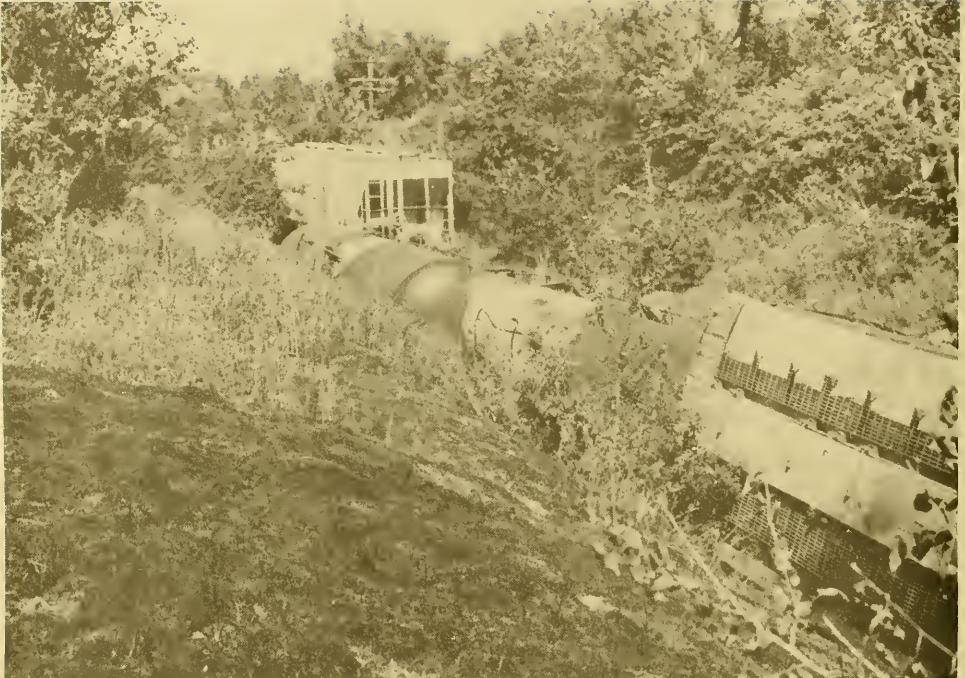
The postaccident visual inspection of the two tank cars on the afternoon of August 2 revealed a dent in the tank shell head at the B-end, or leading end, of ADMX 29477, the lead tank car (second car from the head end) in the train. When facing the B-end, there was a crease on the left side of the tank shell just forward of the first circumferential weld seam in the side shell. The tank shell was scorched and burned around the manway and the pressure relief valve toward the A-end. The scorched and burned area extended about 2/3 the tank length from the manway toward the A-end and on the side of the tank that faced up on the overturned tank. The paint around the manway had been burned away, or was blistered. There was no visible

Figure 7.--Burning at Manway Cover of ADMX 29477 (foreground) and ADMX 29494.

warping, buckling, or other obvious indications of structural damage to the tank shell observed. The bottom outlet valve extension and cap did not have any obvious damage. The manway cover and nozzle were not visibly warped. The area where the gasket contacted the manway cover had some unknown residue that had burned, but had no visible scars or marks.

The A-end of ADMX 29494, which had been the leading end of the car, had no visible damage. A small crease was found in the tank shell on the side that had been on the ground toward the B-end of the tank car. The tank shell was scorched around the manway opening and the pressure relief valve toward the A-end of the car. The scorched area extended around the side of the overturned tank that faced up, but it did not extend toward either end of

the tank. The paint in areas adjacent to the scorching was blistered. The bottom outlet valve extension and cap showed no visible damage. The manway nozzle and lid were not visibly warped or deformed.
